# BEZPEČNOST V LZS

## - NEHODY A INCIDENTY -

### KOMENTOVANÝ PŘEHLED NEJČASTĚJŠÍCH PŘÍČIN NEHOD

Letecká záchranná služba Hradec Králové – Kryštof 6  
Zdravotnická záchranná služba Královéhradeckého kraje

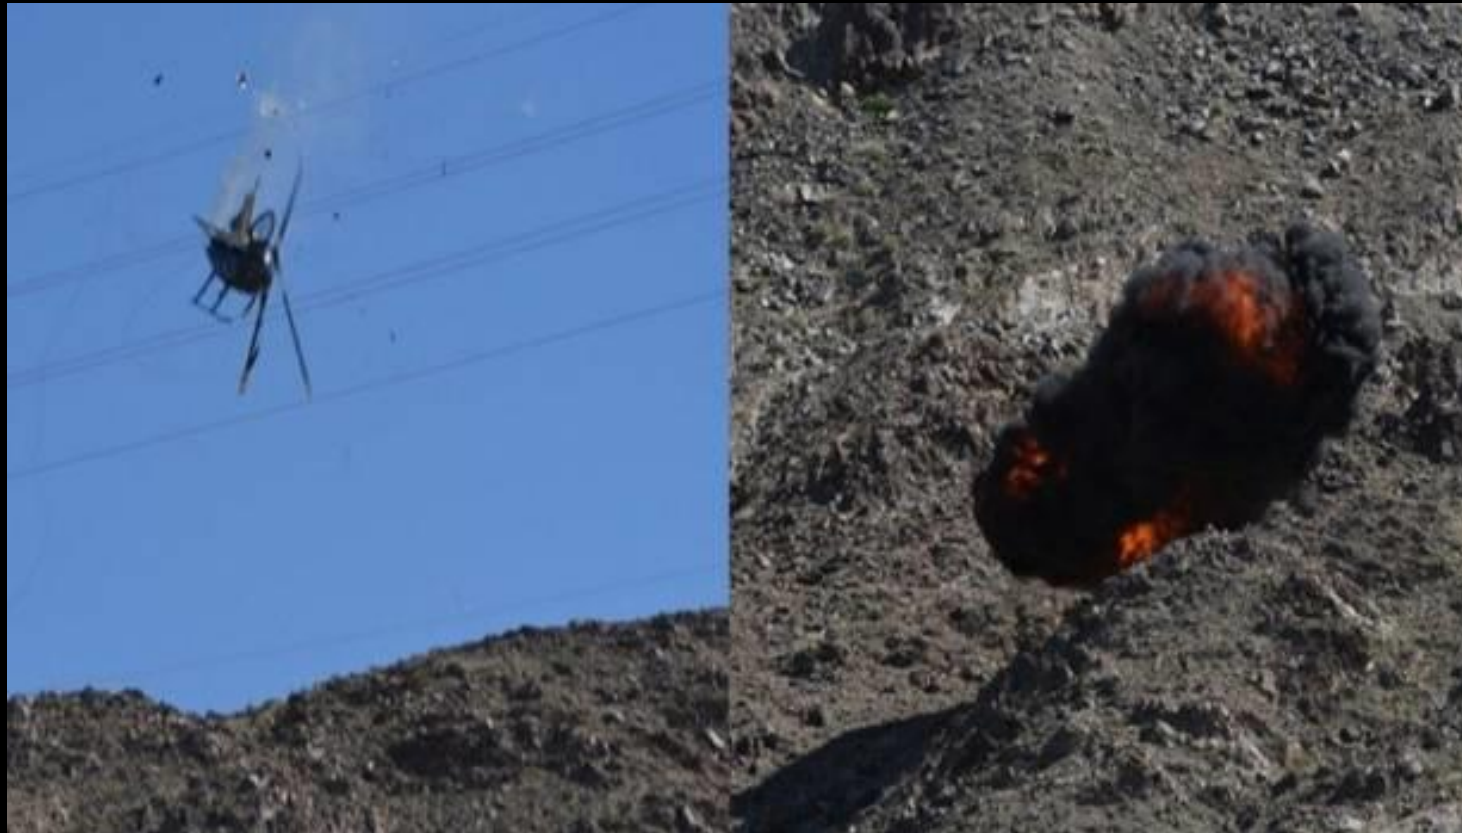
**Foreign Incident Report**  
**4 Die During Body Recovery**  
**March 14, 2017 – Mexicali, Mexico**

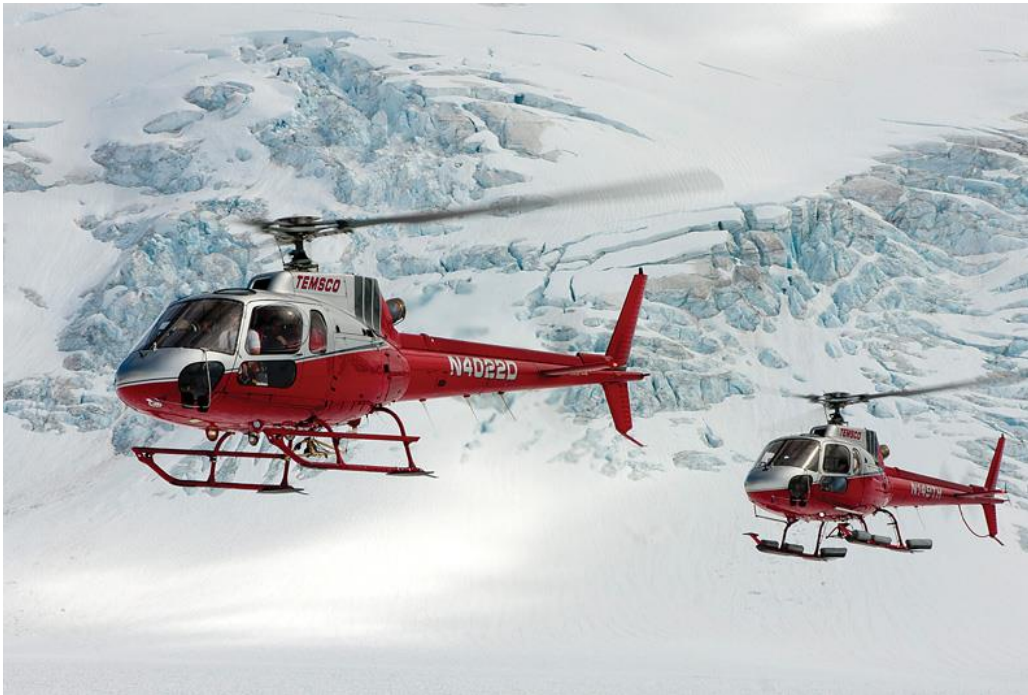
# Flat Light Led to Loss of Horizontal Reference

**Flat light led to loss of  
horizontal reference...**

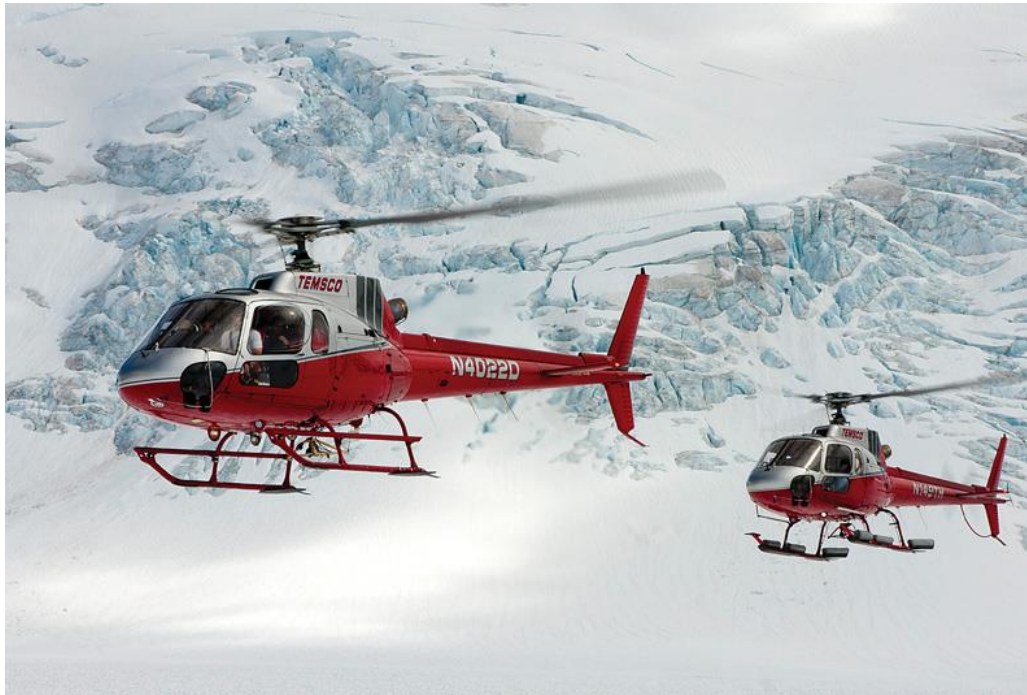
# Helicopter Crashes Rescuing Survivors of Another Crashed Helicopter

**Flat light led to loss of  
horizontal reference...**

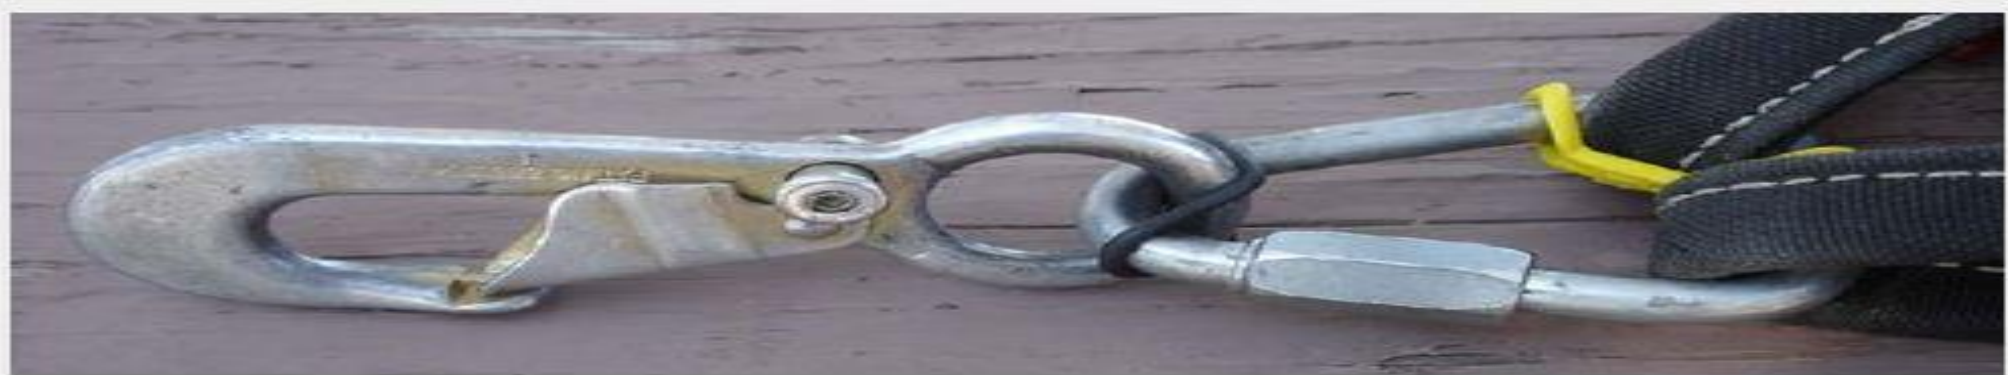
— "J" hook, Tri-link, and an "O" Ring, correctly installed. USFS photo.

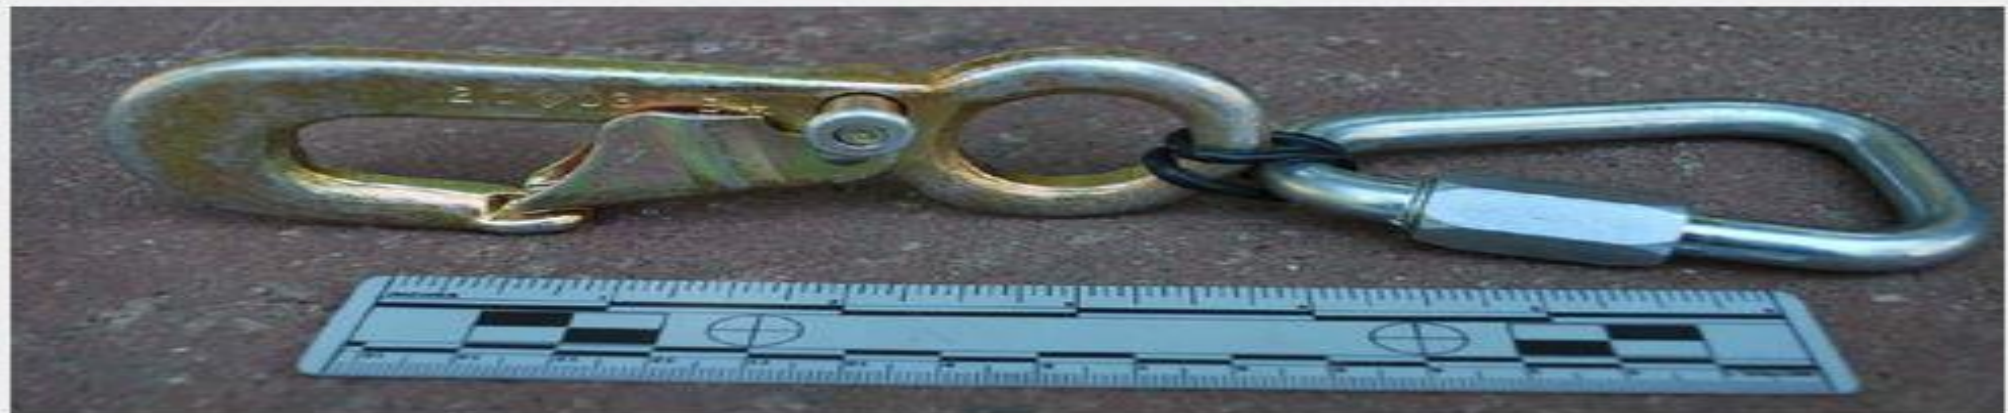
— "J" hook, Tri-link, and an "O" Ring, incorrectly installed. USFS photo.

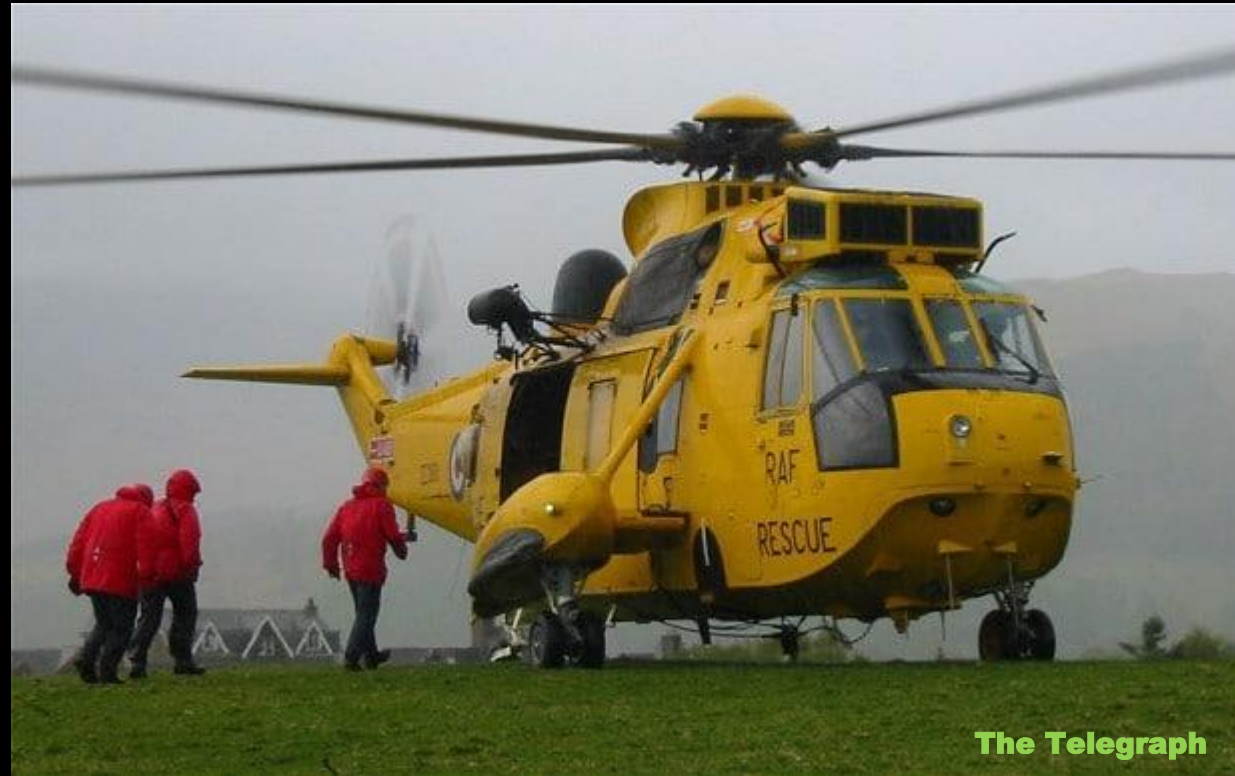
# **Rescuer Cuts the Wrong Rope Climber Dies from Subsequent Fall February 13, 2013 – Ben Nevis, Scotland**

- *The winchman (hoist rescuer) verbally "expressed concern at the complexity of the rescue"* to the flight crew raising the option of involving the ground rescue team.
- *Complexity of the rope system encountered by the winchman* upon reaching the accident scene.

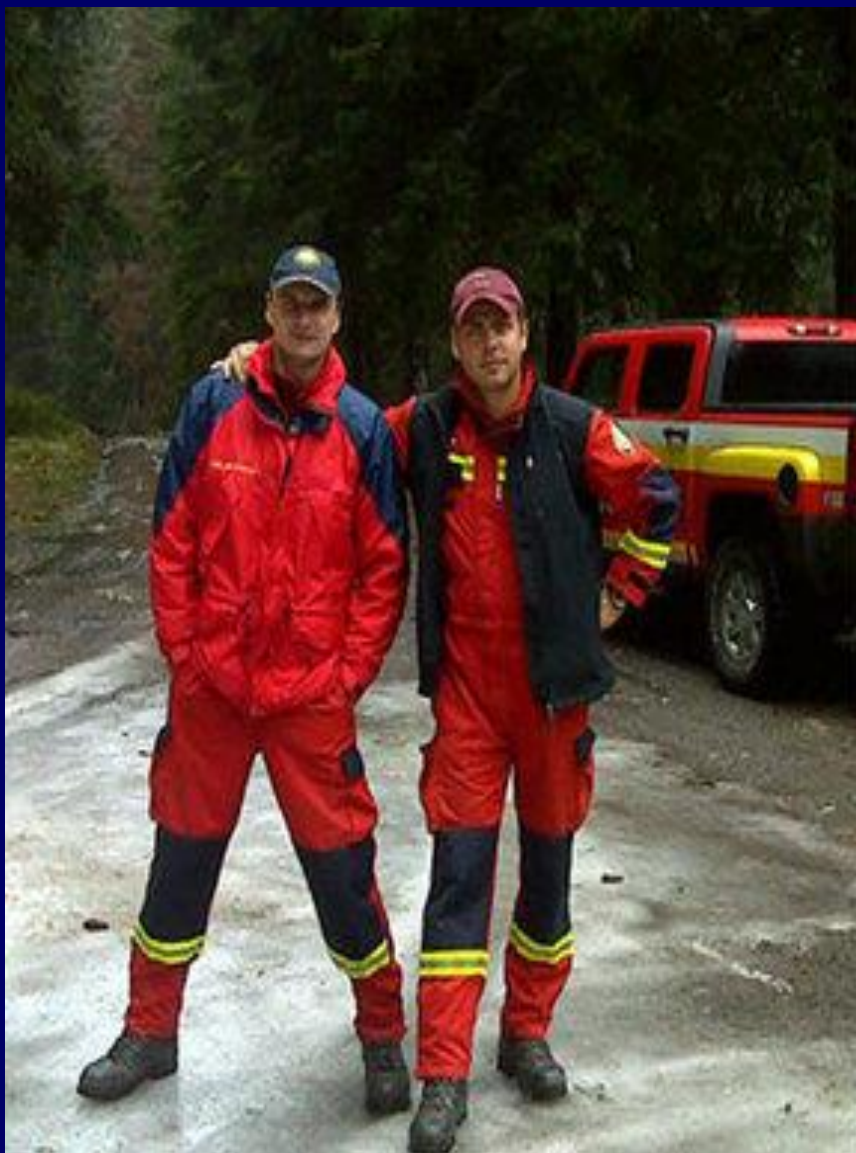
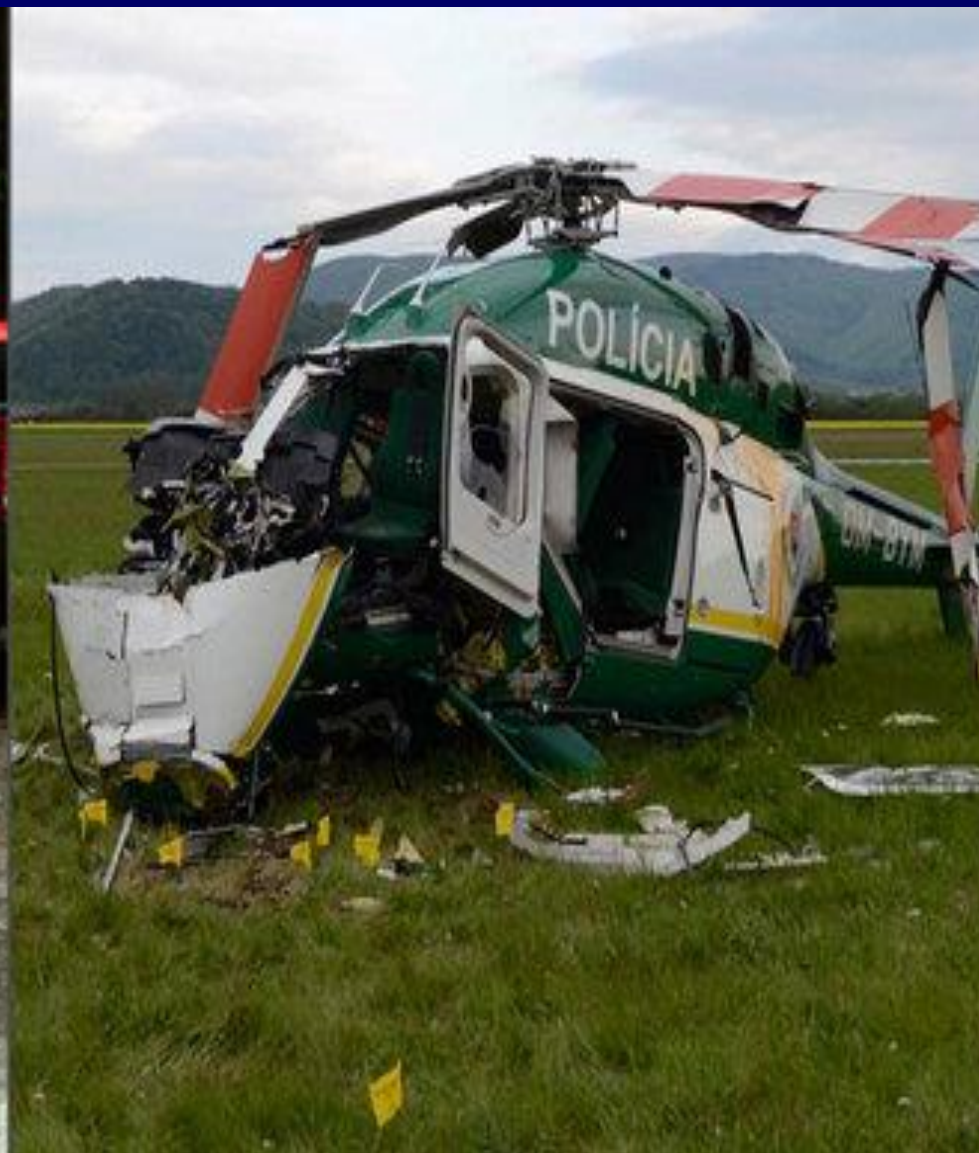
SK – Prešov – 11.5.2017 (2 ✚, 2 zr.)

# KONTAKT S DRÁTY EL. VEDENÍ
