# BEZPEČNOST V LZS

## - NEHODY A INCIDENTY -

### KOMENTOVANÝ PŘEHLED NEJČASTĚJŠÍCH PŘÍČIN NEHOD

Letecká záchranná služba Hradec Králové – Kryštof 6  
Zdravotnická záchranná služba Královéhradeckého kraje

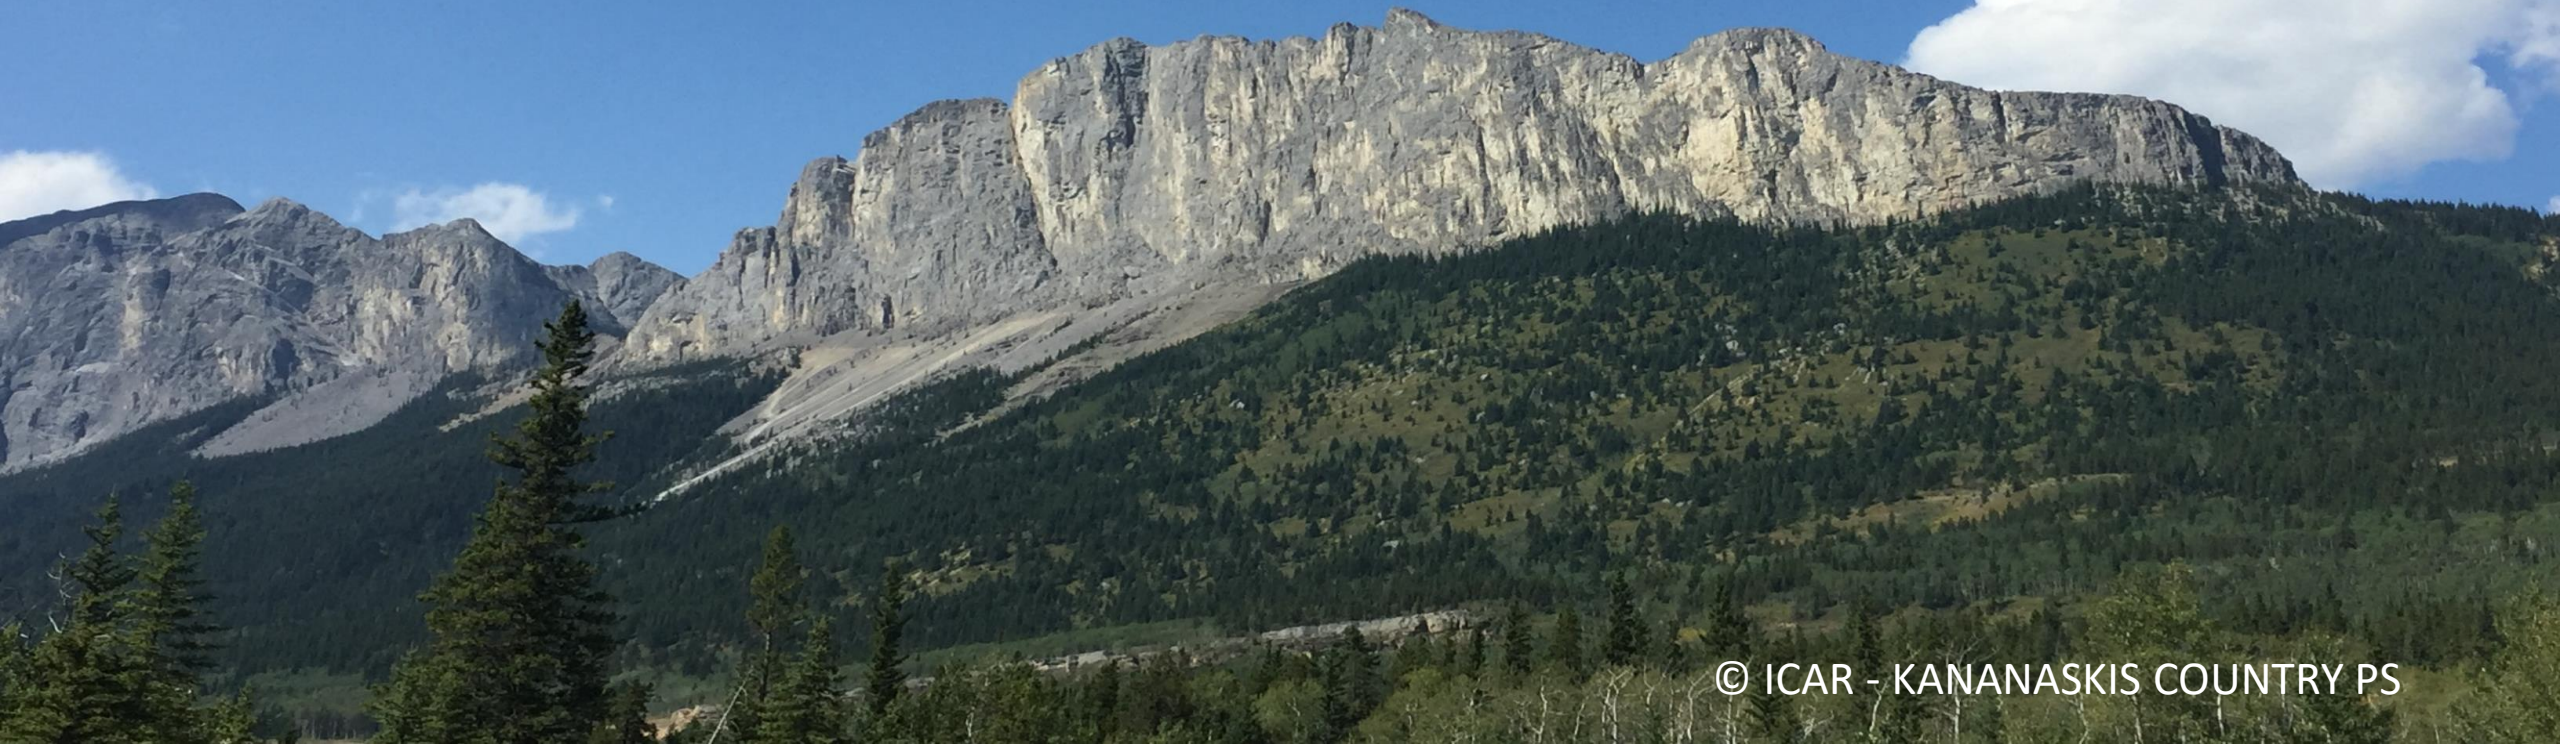
# Rotor vs Rock

## A Main Rotor Strike During a Live Slinging Operation

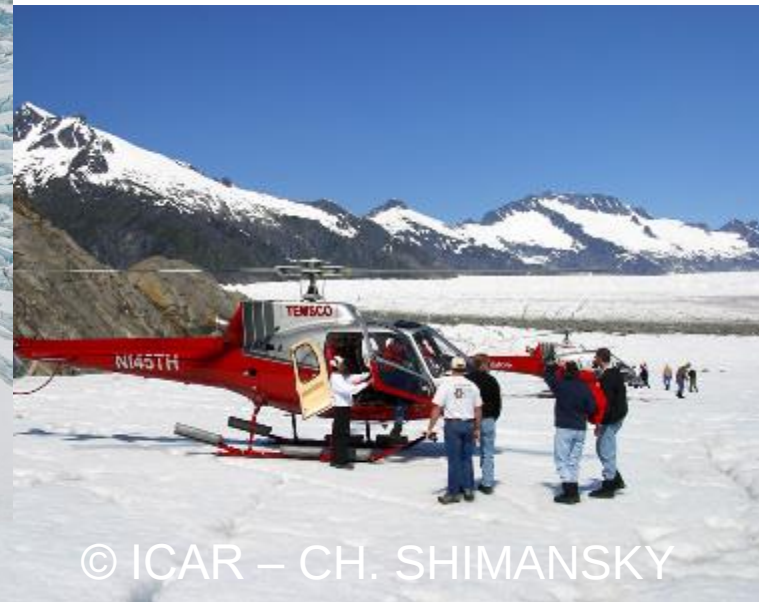
# Flat Light Led to Loss of Horizontal Reference

September 10, 1999 - Juneau Ice Fields, AK

**Flat light led to loss of  
horizontal reference...**

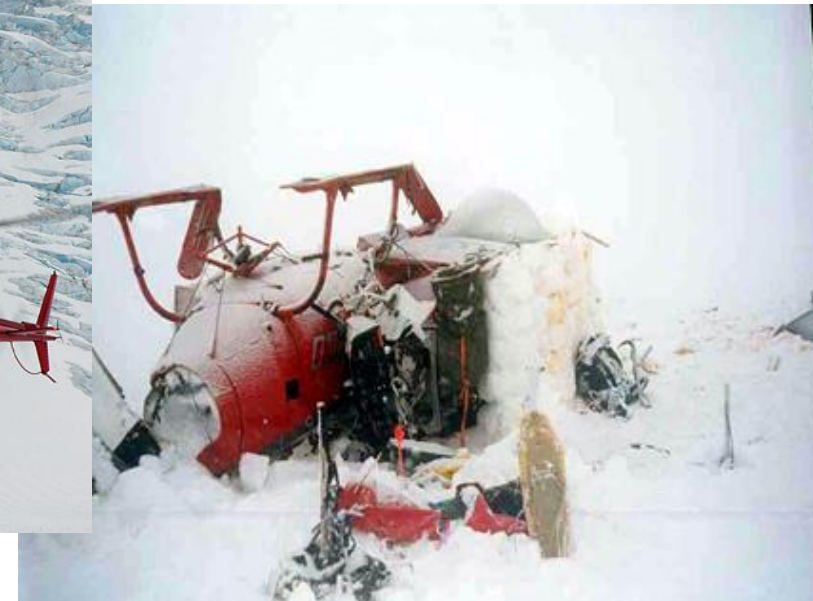
# Helicopter Crashes Rescuing Survivors of Another Crashed Helicopter

**September 10, 1999 - Juneau Ice Fields, AK**

**Flat light led to loss of  
horizontal reference...**
